PRE-PURCHASE YELLOW BOOK

Type Of Inspection

Comprehensive Inspection

E46 M3

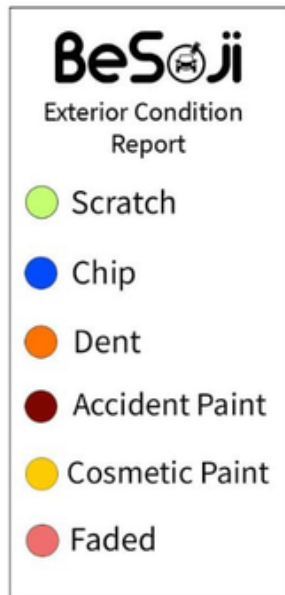
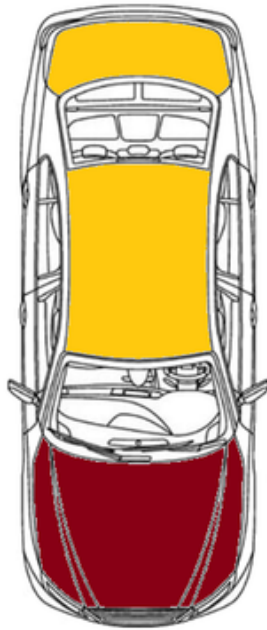
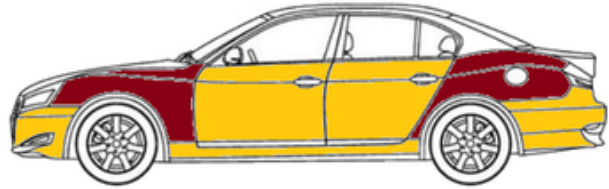
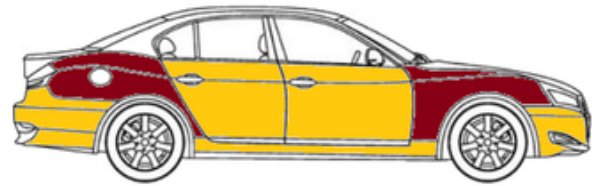
Paint Condition Report

- **Scratch:** A minor or major scratch
- **Paint Chip:** A small to medium part of the paint has been removed
- **Dent:** A minor or major depression or hollow on the vehicle body
- **Accident Paint:** Filler used to smoothen out the panel due to a deep crack or damage, followed by repainting of the panel.
- **Cosmetic Paint:** No filler used, usually a repaint due to minor imperfections on the paint. e.g. stone chips, door dings, etc.
- **Faded:** Paint and/or lacquer has been worn out due to extreme weather. Appears as a dull, washed out appearance and, at times discoloration.

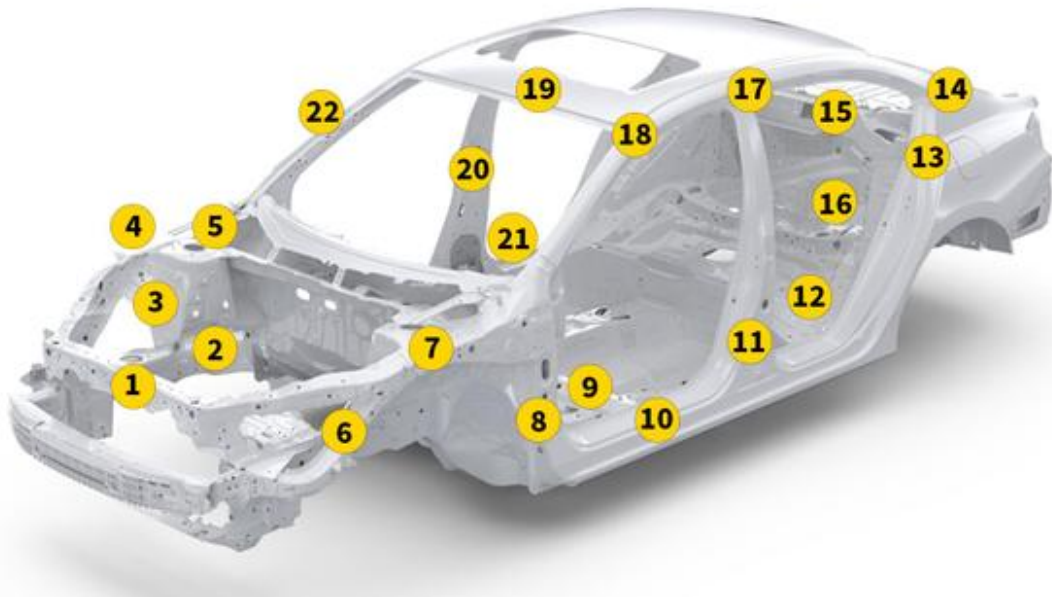
Chassis, Subframe & Internal Damage Report

Damage on Chassis / Subframe:

PASS
